Navajo Abandoned Uranium Mine Site Screen Report

Haystack No. 1 AUM Site

Weston Solutions, Inc.

May 2009

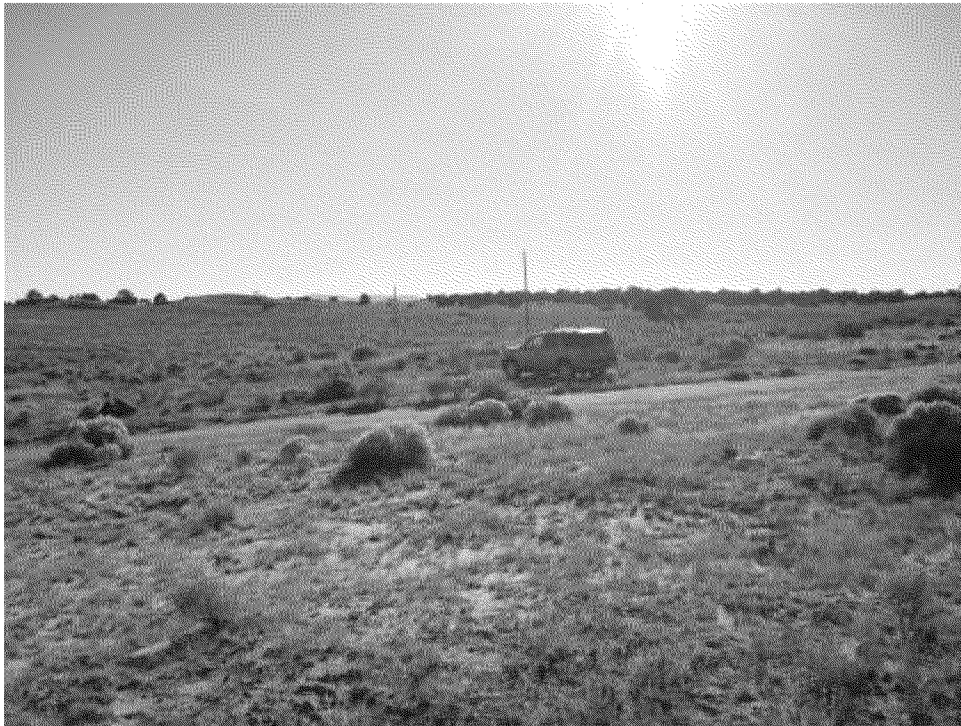
Photo 1. Haystack No 1 Mine site, towards the southwest

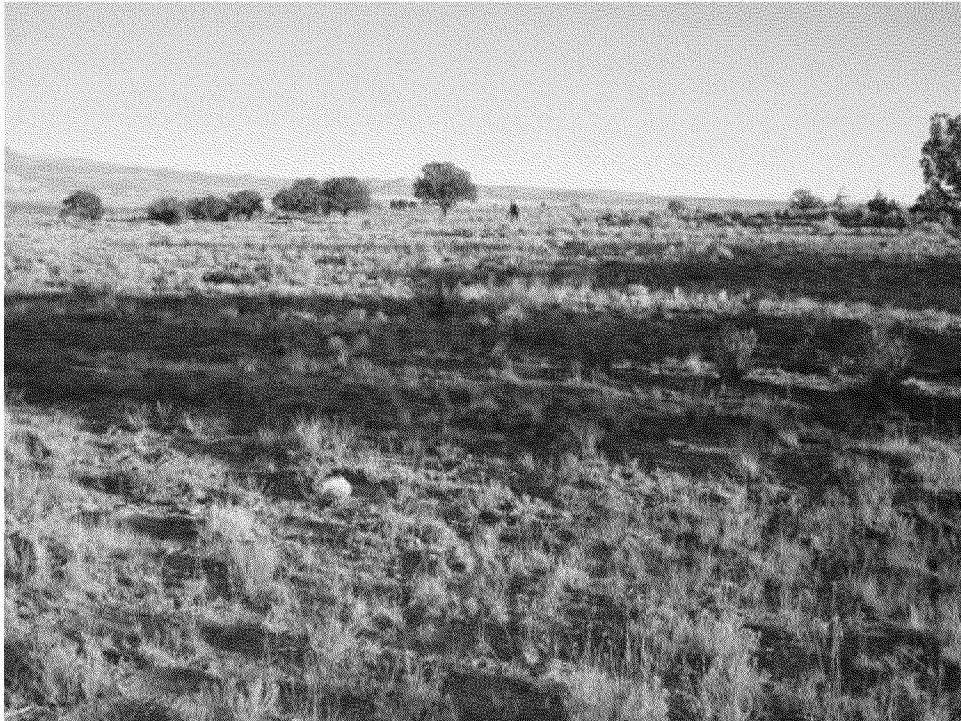
Photo 2. Haystack No 1 Mine site, towards the south

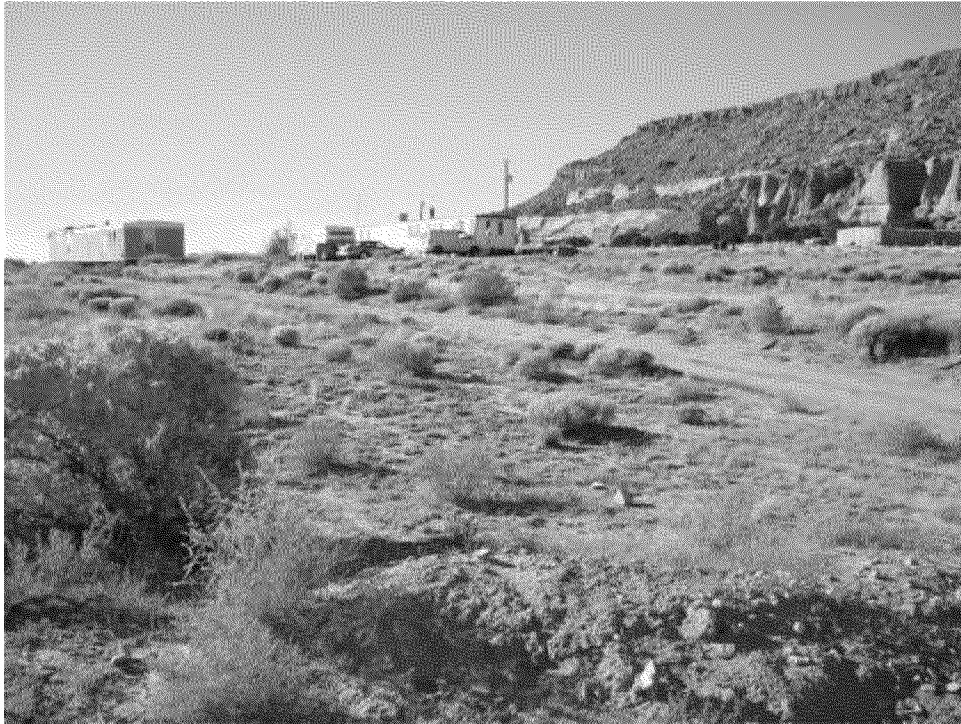
Photo 3. Haystack No 1 Mine site, residence (Tom and Lenea Vandever) locate on the mine site

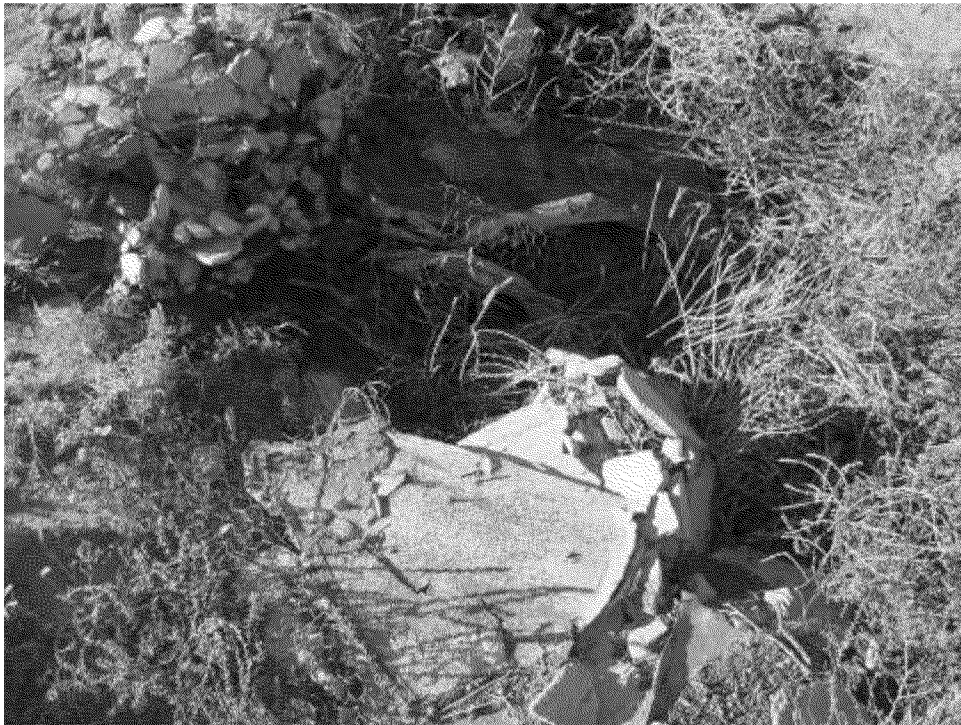
Photo 4. Haystack No 1 Mine site, open hole or vent near residence

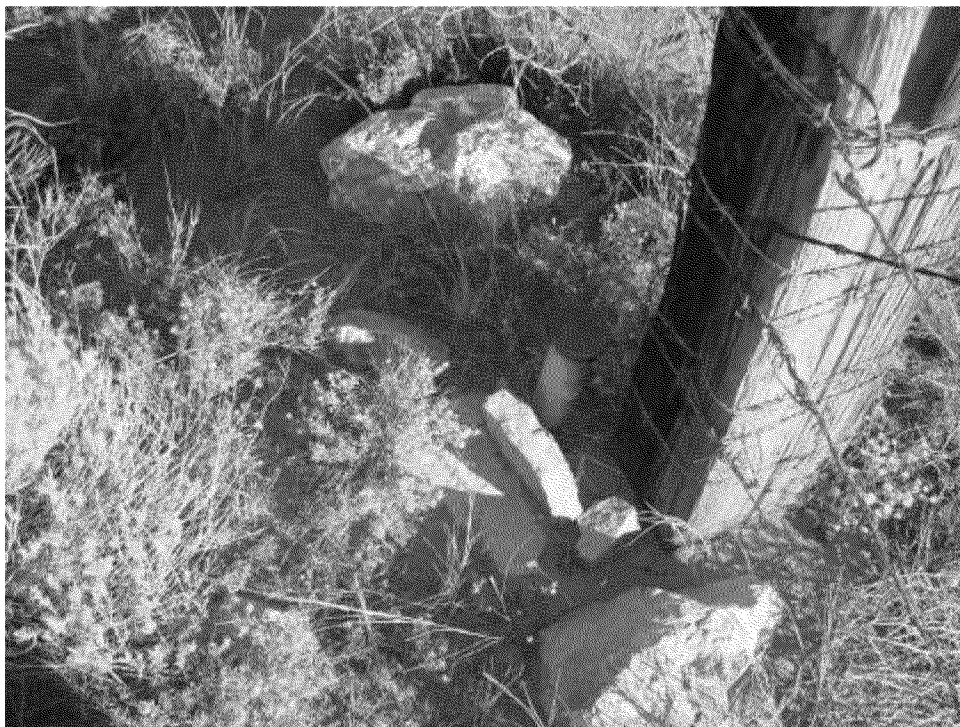
Photo 5. Haystack No 1 Mine site, section corner survey marker

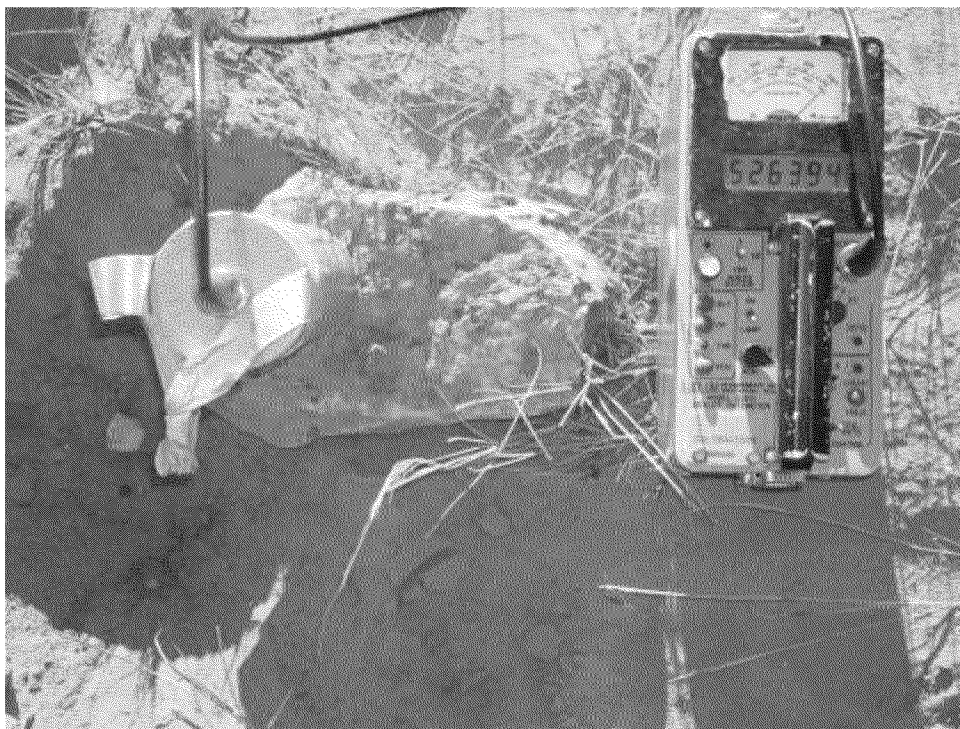
Photo 6. Haystack No 1 Mine site, gamma radiation emitting 500,000 cpm from waste rock located near residence

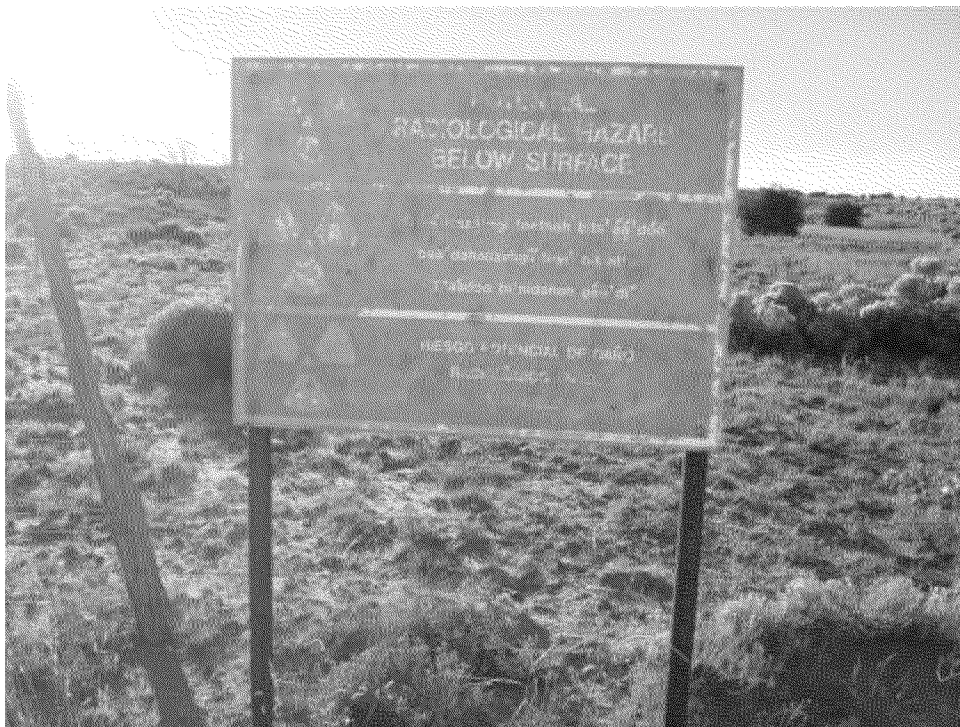
Reclamation status of the mine sites are currently unknown. The mine appears to have been reclaimed. The portion of the mine on private property was fenced and posted with signs warning of underground radiological hazards. The signs were faded and nearly illegible. No adits or other mine features were observed during the site visit.

Photo 6. Haystack No 1 Mine site, faded sign posted on portion of mine located on private property warning of subsurface radiological hazards

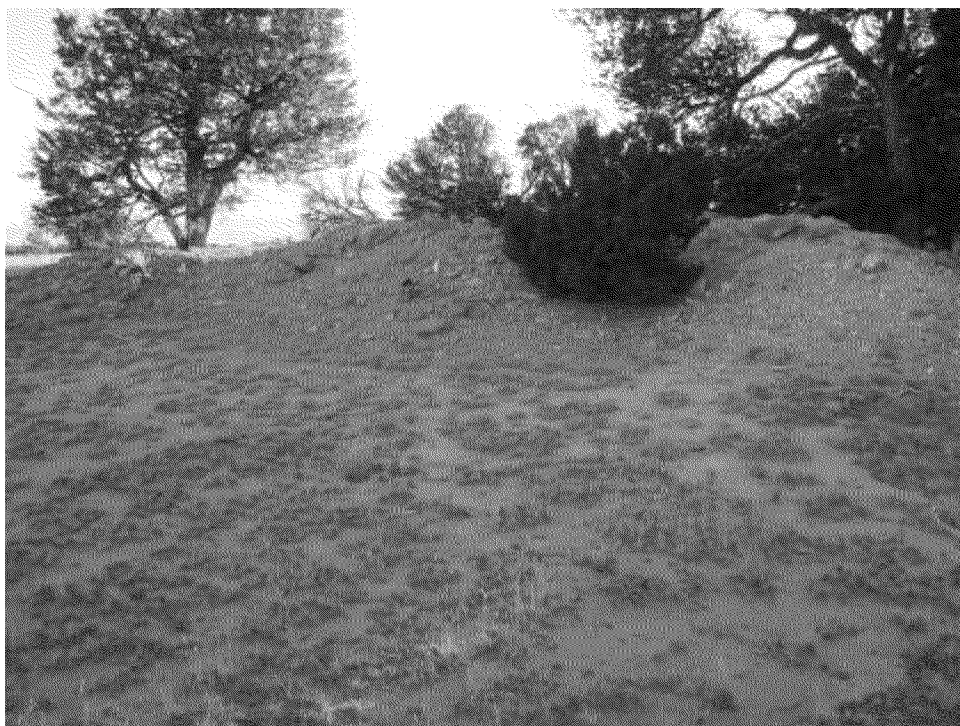
Photo 6. Haystack No 1 Mine site, waste piles on mine

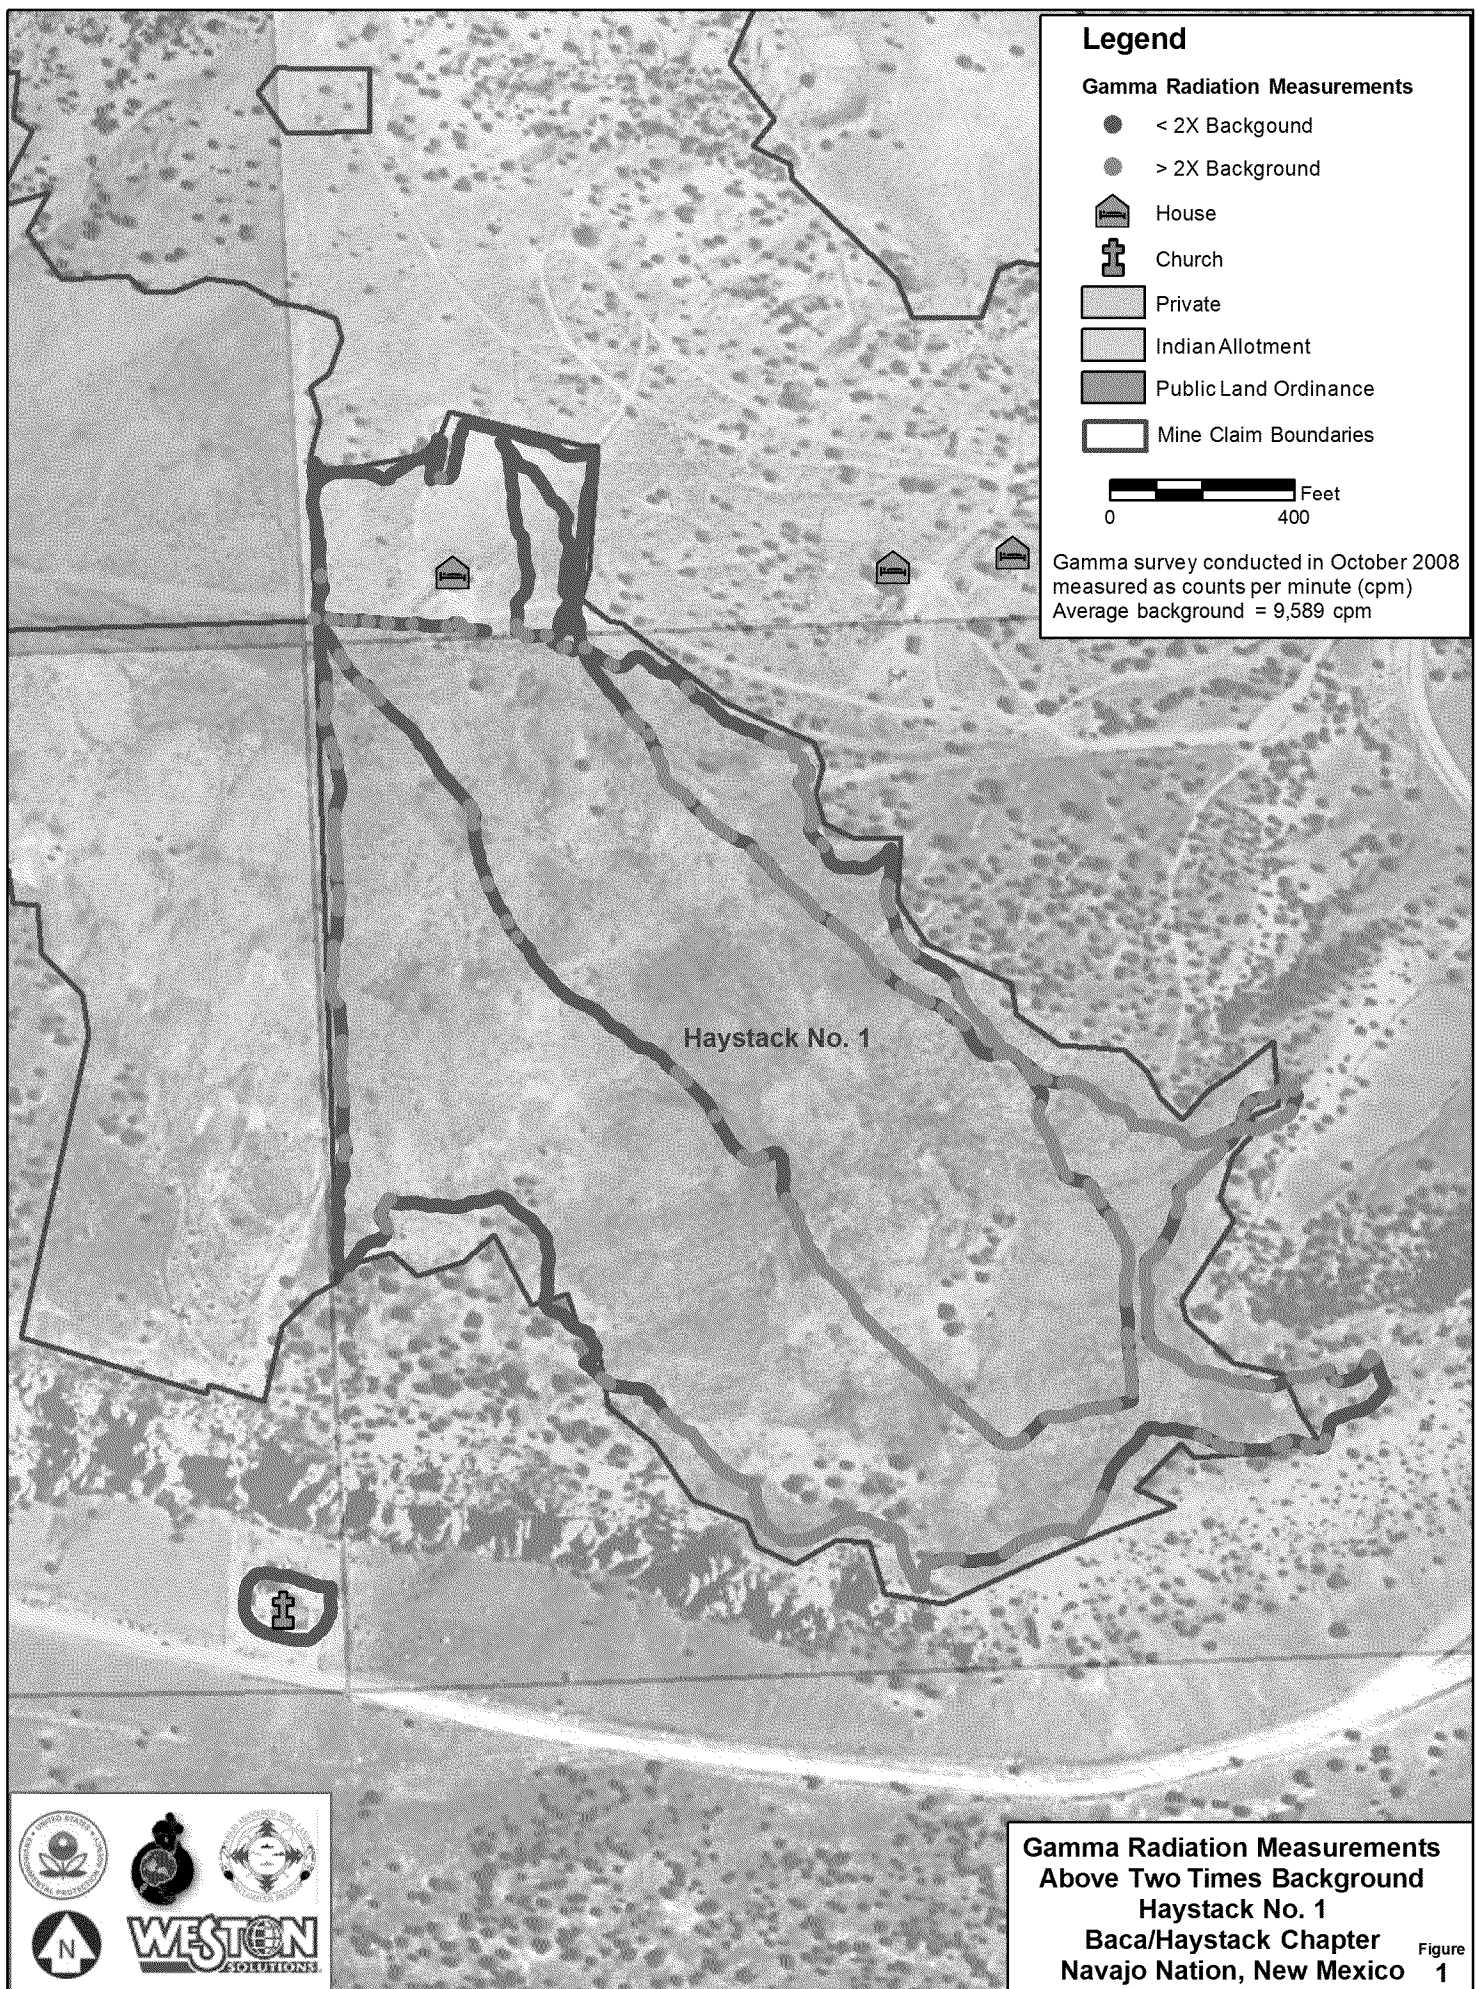
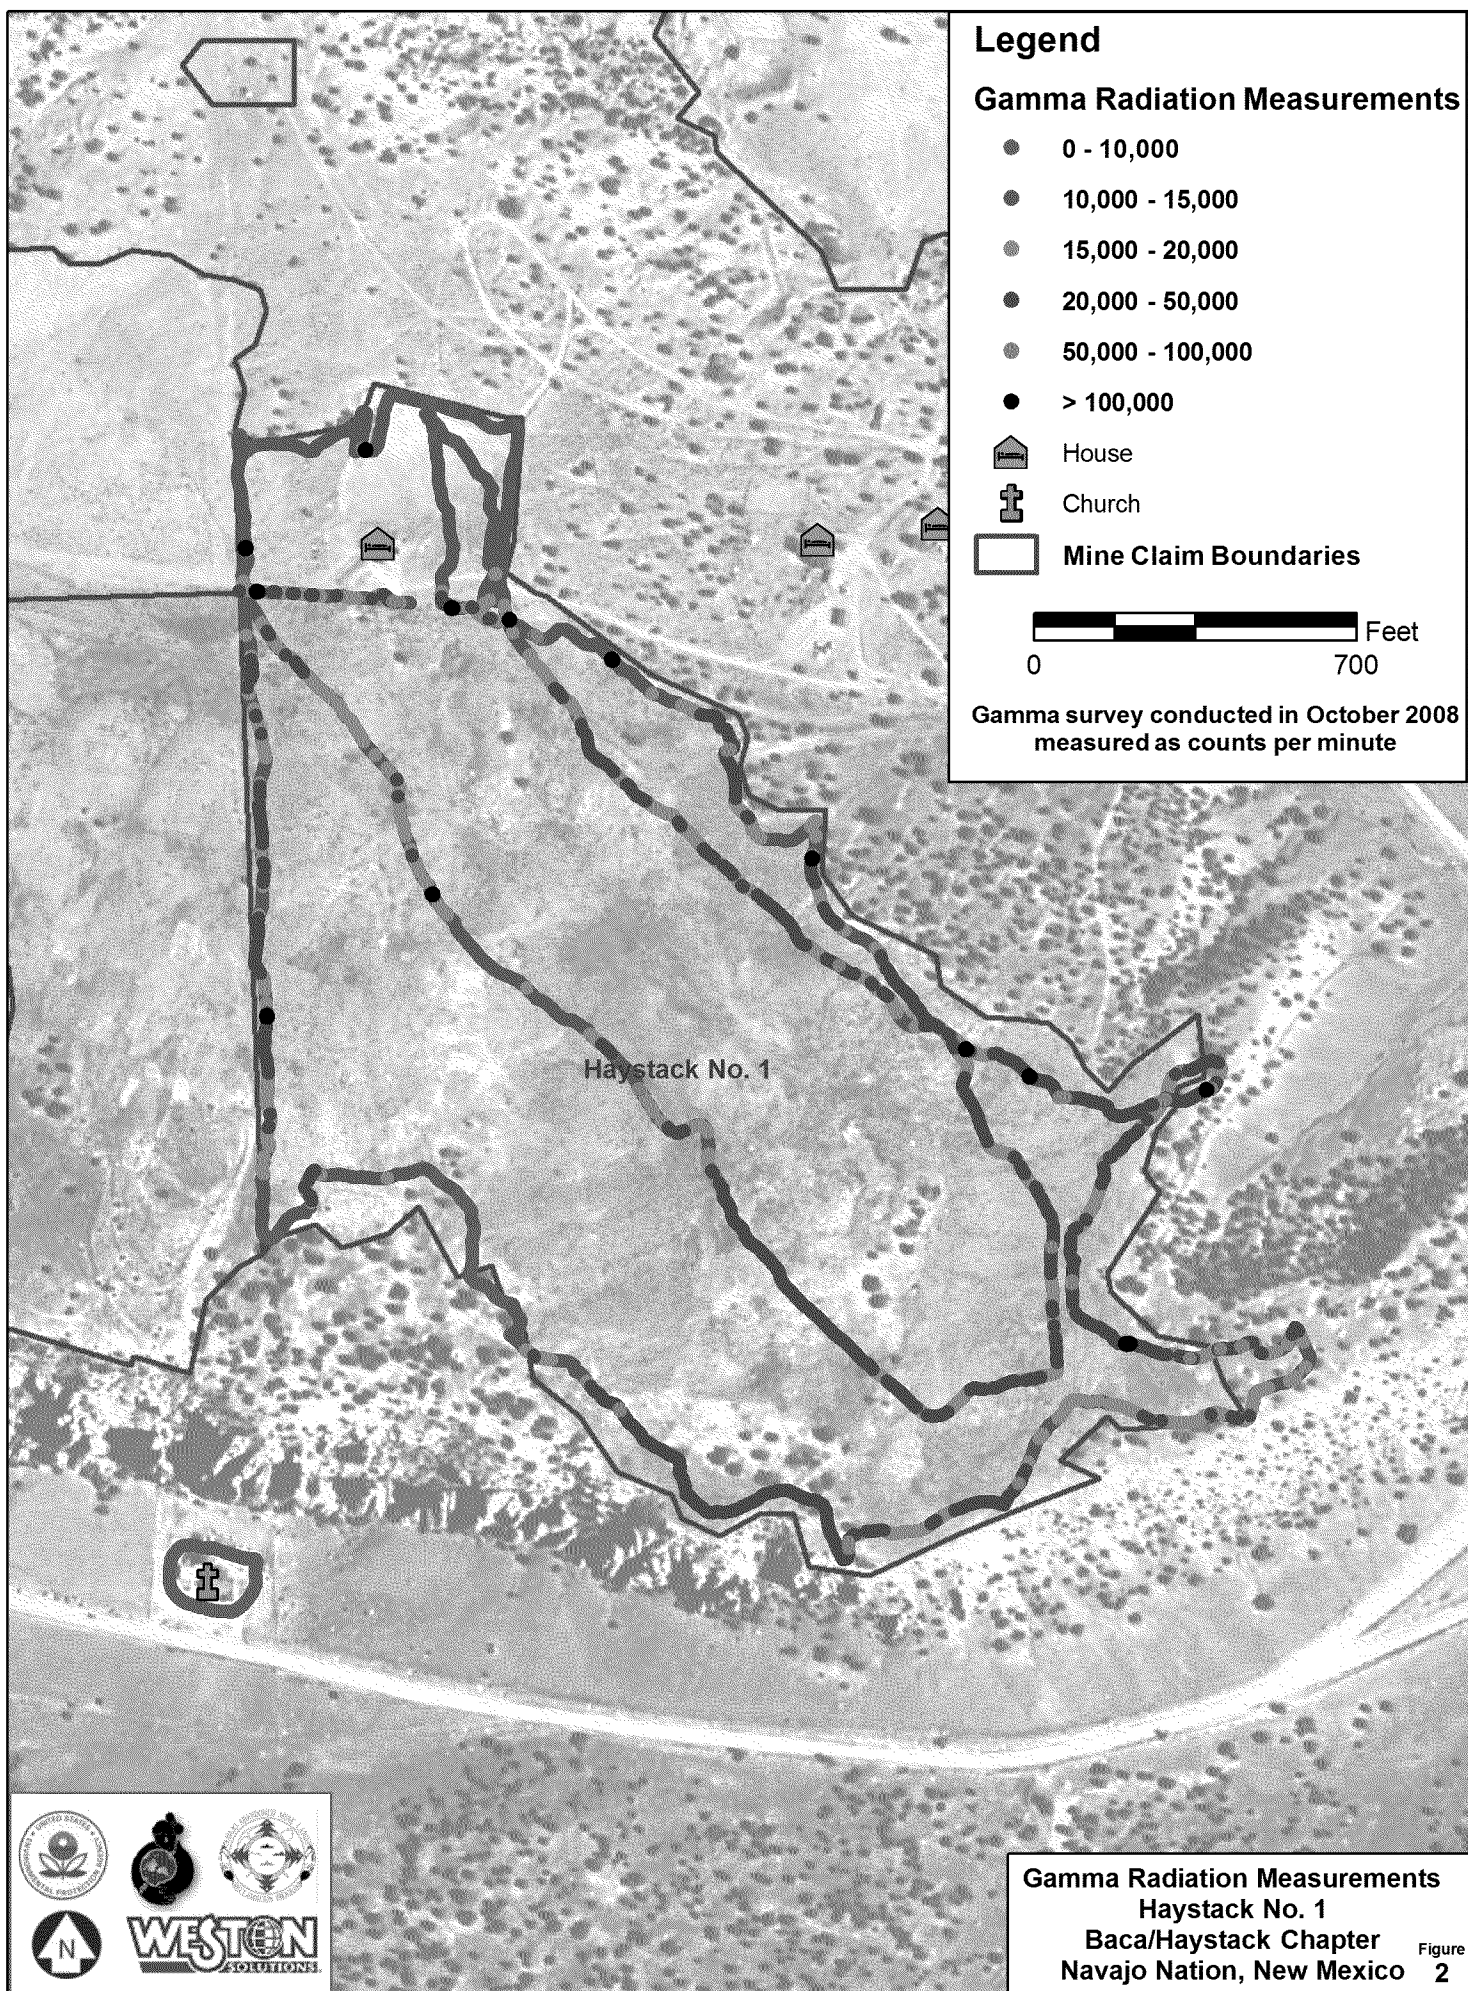
A total of 7,045 gamma radiation measurements were collected from mine sites, ranging from 5,965 cpm to 626,434 cpm. The measurements are represented in Figures 1 and 2.
